ANALYSIS FOR TOXIC MATERIALS IN SEDIMENTS FROM HURRICANE IKE IN GALVESTON, TX

**Videographer: Bryan Parras, Texas Environmental Justice Advocacy Services
(TEJAS)**

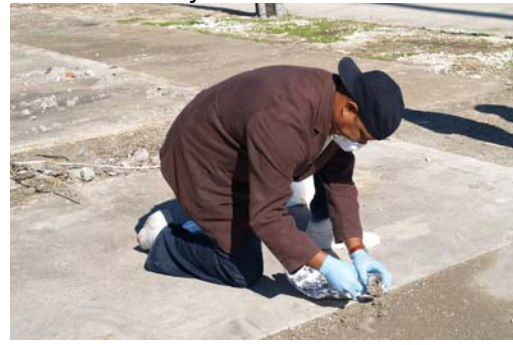
All of the samples were collected using procedures that conform to USEPA Guidelines.¹ The sample collection team included community members as well as the investigators. Dr. Subra provided training to the sample collectors. Sediment was collected in areas where it could be distinguished from pre-existing soil or other material. In several locations the sediment was collected off of solid surfaces such as concrete slabs, flooring, or machinery. In three locations the sediment was collected from locations that were covered and not affected by rain or sun exposure following the flood event. The sediment was collected into acid-washed glass sample jars with screw-capped lids that were provided by the analytical laboratory. A clean stainless steel spoon was used to scrape the sediment from the surface as shown in Figure 2. The individual collecting the

Figure 2. The sample collection procedure included use of protective equipment and documentation through chain of custody forms.

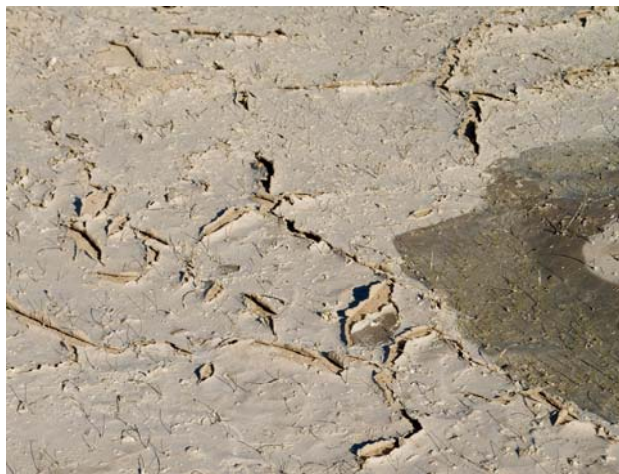
Figure 3: *The sediment from Hurricane Ike found in Galveston has the smooth texture of fine mud that cracks when it dries. It is generally about 1/8 of an inch thick, and was clearly visible on hard surfaces such as concrete sidewalks. It is notable that at each of the preliminary sites visited, obvious sediment could easily be found despite several hard rains since the storm.*
